DEM Quality Determines Watershed Accuracy

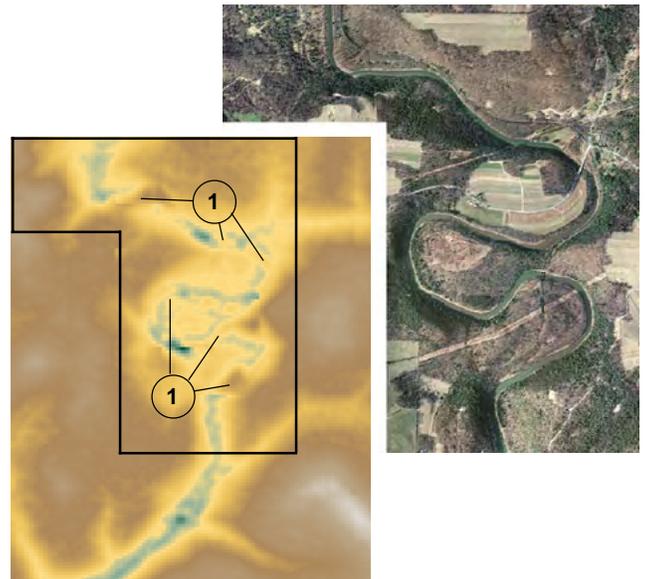
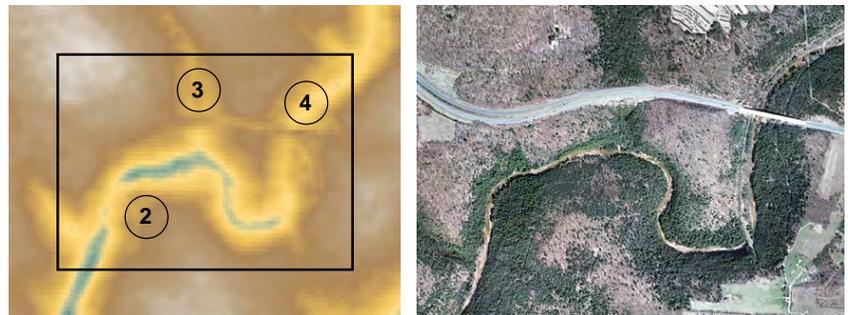
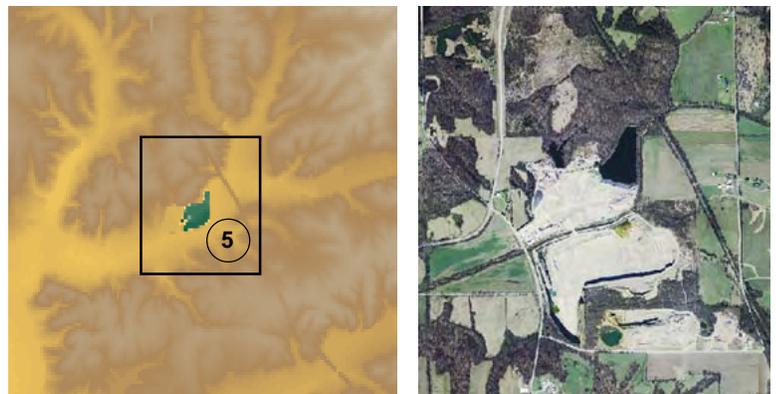
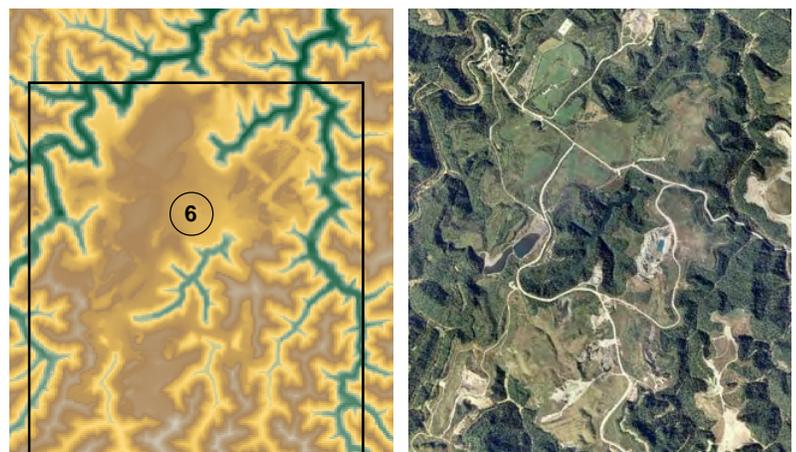
Local Elevation Anomalies Encountered in 1 arc-second (30-meter) NED
(numbers keyed to illustrations)

- ① General poor data quality producing stream valley blockages; probably older data produced by photogrammetric methods.
- ② Anomalously high elevations in stream valley in area with patches of coniferous forest (dark green in leaf-off color orthophoto); data probably produced by photogrammetric methods.
- ③ Highway embankment depicted in DEM blocking stream valley.
- ④ Highway bridge depicted in DEM blocking stream valley.
- ⑤ Quarry creates local artificial depression in wide stream valley.
- ⑥ Strip-mined area with ridges removed and spoils dumped in adjacent valleys; wholesale blockage of drainages.

United States by photogrammetric methods (manual profiling and electronic image correlation) include striping artifacts, anomalously high elevations in areas of forest cover, and patchy areas of poor elevation quality. Some of this older, poor-quality data persists locally in the current National Elevation Dataset (NED) of the United States distributed by the U.S. Geological Survey. As examples of the elevation errors that may occur, some of the production artifacts that MicroImages has encountered in the 1 arc-second (approximately 30-meter cell size) NED are tabulated and illustrated below along with color orthoimages of the problem areas.
